**ELLIS ISLAND
STATUE OF LIBERTY NATIONAL MONUMENT**

**HISTORIC STRUCTURES REPORT
UNITS 2, 3 AND 4**

**Volume 4
Part Two**

**Beyer Blinder Belle/
Anderson Notter Finegold**

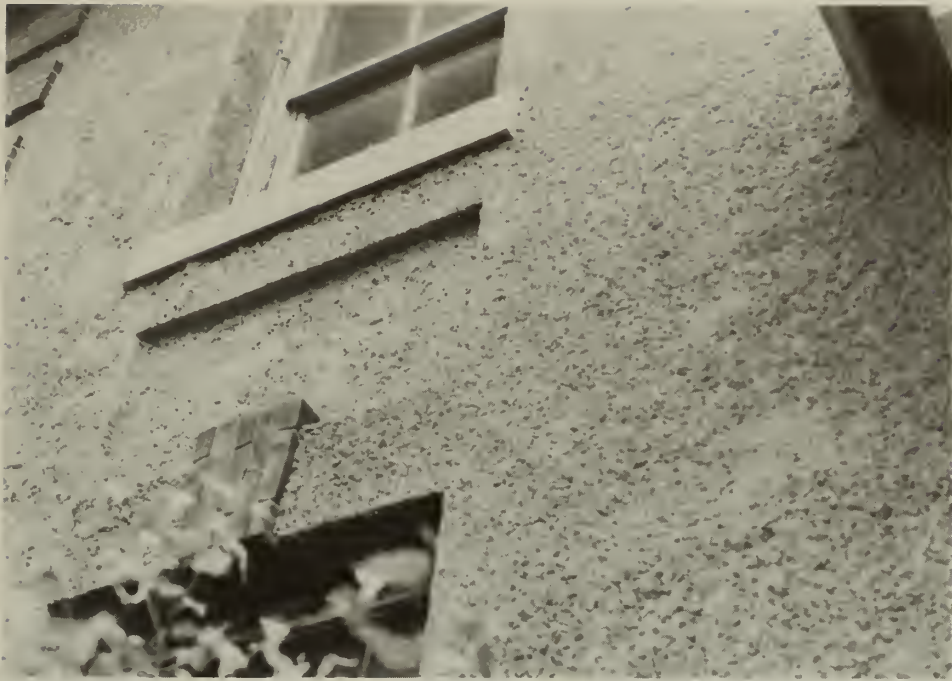
The pebble dash surfaces of the office building are in fair condition and suffer generally from random loss of surface pebble aggregate leaving a more finely grained cementitious stucco undersurface (photo 8). Although the material appears stable on the surface, some separation of the hard outer layer from its subsurface has occurred, causing cracking. This is accompanied by underlying spaces which allow

8. Patches of missing aggregate, pebble dash surface of west elevation.

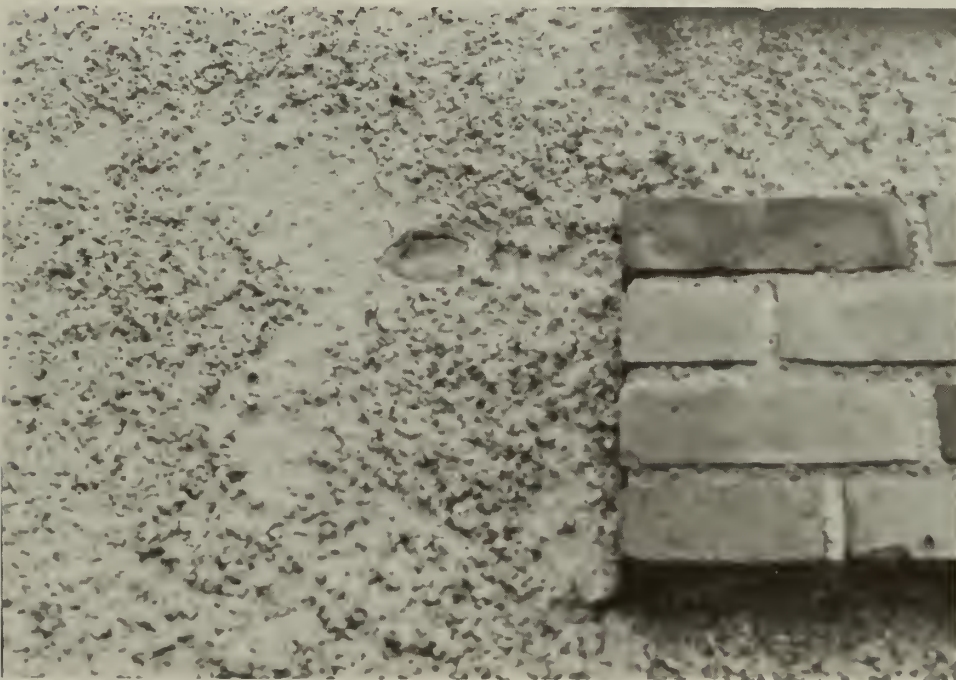
water penetration, causing areas of general displacement and deterioration (photo 9). The surfaces of the mortuary do not exhibit the same conditions and loss of pebble dash surface in that building is confined to areas damaged by the removal of a downspout.

9. Missing patch of pebble dash, first story, north end of west elevation.

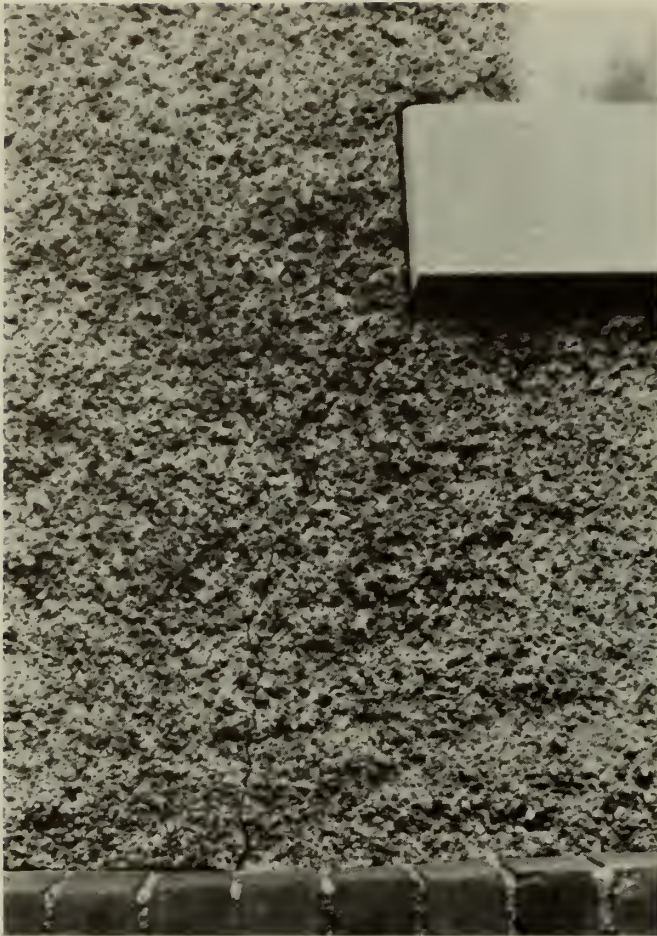
10. Crack, first story, north end, west elevation.

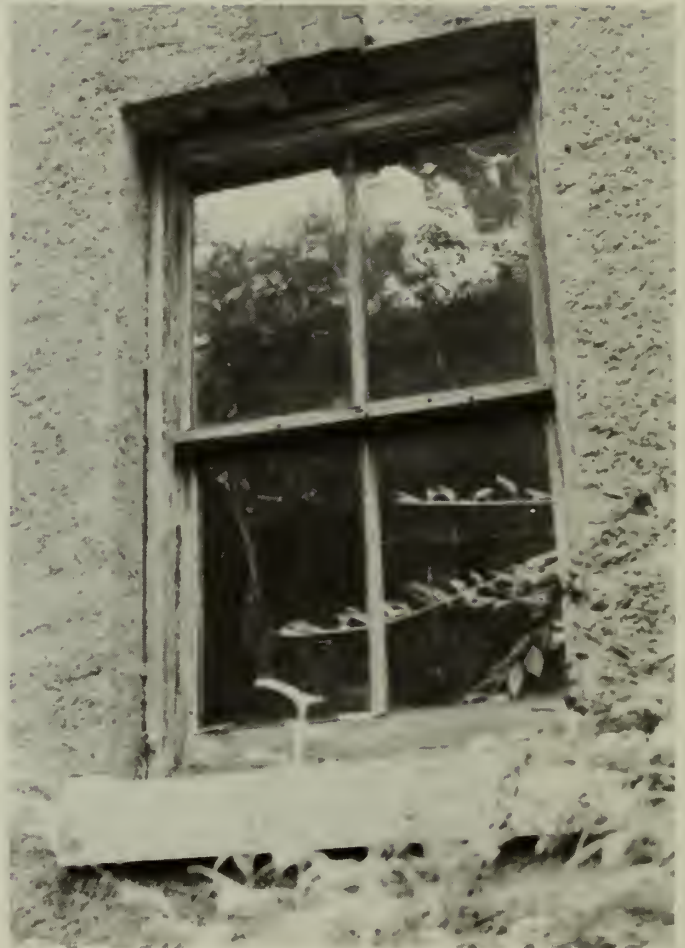
11. Carbon soot staining beneath window lintel, east elevation.

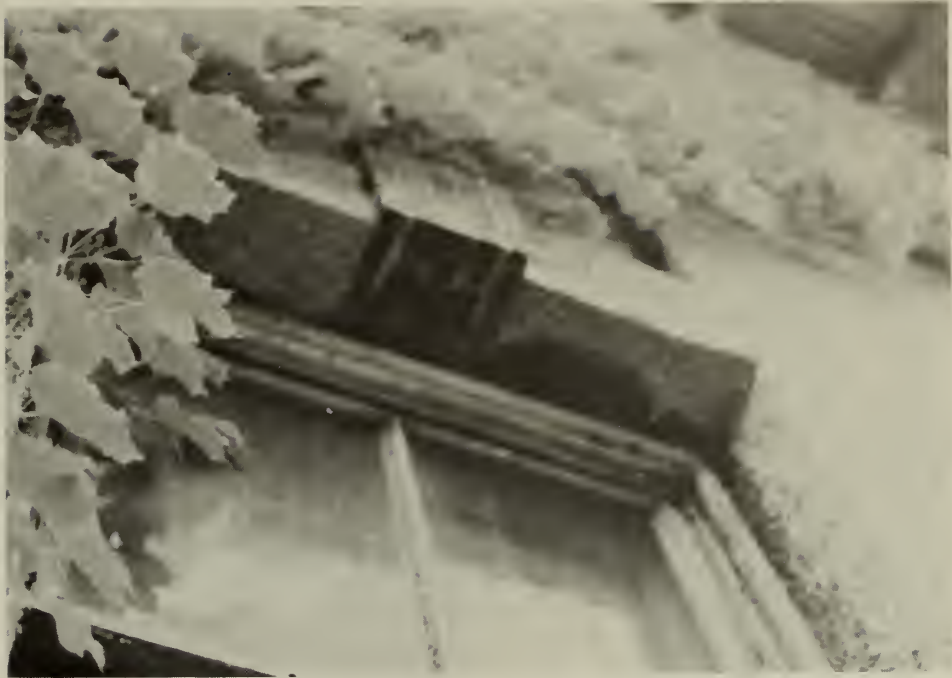
Carbon soot staining is evident below all building projections such as window sills and roof eaves, being particularly severe in protected areas such as the west elevation of the mortuary and the north face of inset panels; the inside face of window and door openings of both structures; and becomes progressively more concentrated in southern sections of the facades (photo 11). Green biological staining occurs spottily on low pebble dash surfaces of the south and east elevations of both structures, extending to cover the lower one-half of the surfaces of the buildings' north and west facades. Vine-cover clings to areas of the pebble dash facade which could contribute to deterioration of stucco surfaces (photo 12).

12. Vinecover, carbon soot staining beneath window lintel, east elevation.

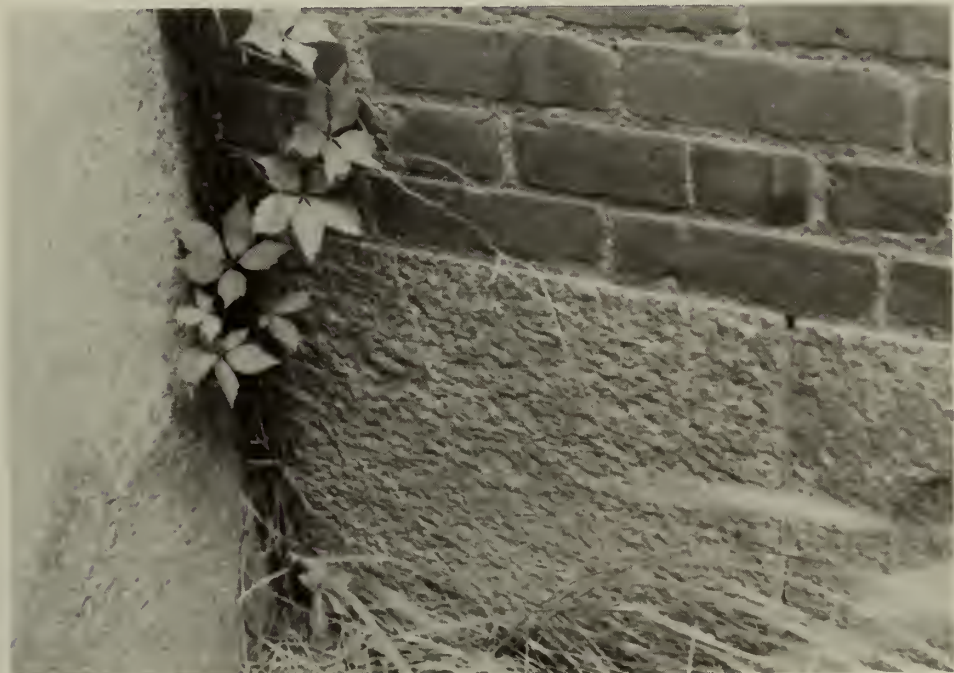
The brick base, quoins, voussoirs, and upper wall coursing of the office building exhibit carbon and green biological staining, the latter being most severe on the north and west elevations of both buildings (photo 13). Mortar is discolored by staining but is in generally good condition with some spotty loss.

13. Biological staining, base of north elevation west of portico.

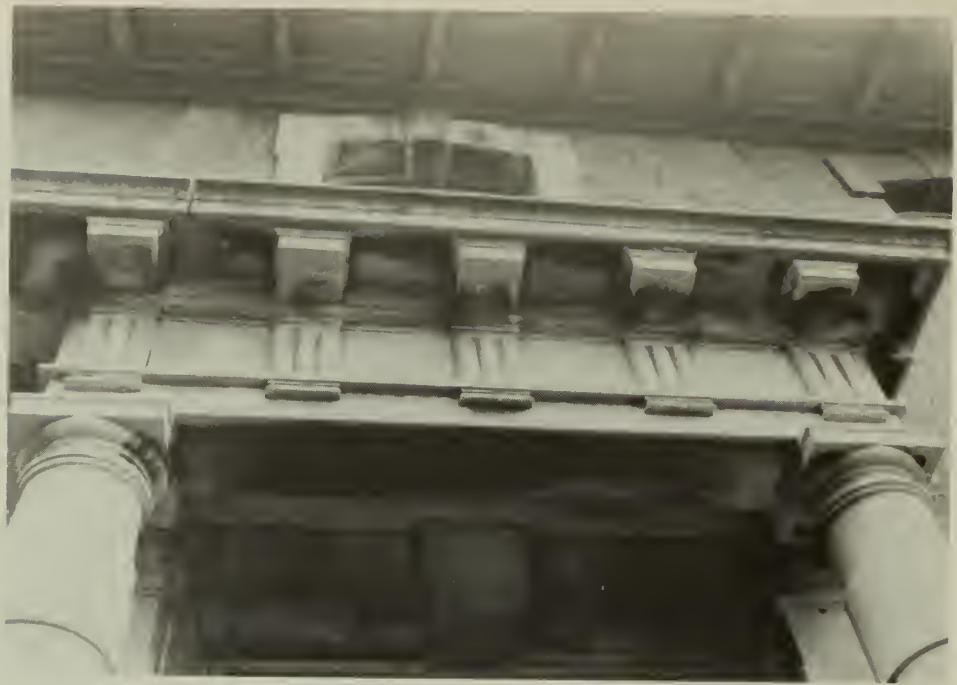
Limestone exhibits the typical weathering found on all Ellis Island buildings with some carbon soot and copper staining of window sills and the portico entablature of the office building (photo 14).

14. Carbon soot staining, dentils of north portico.

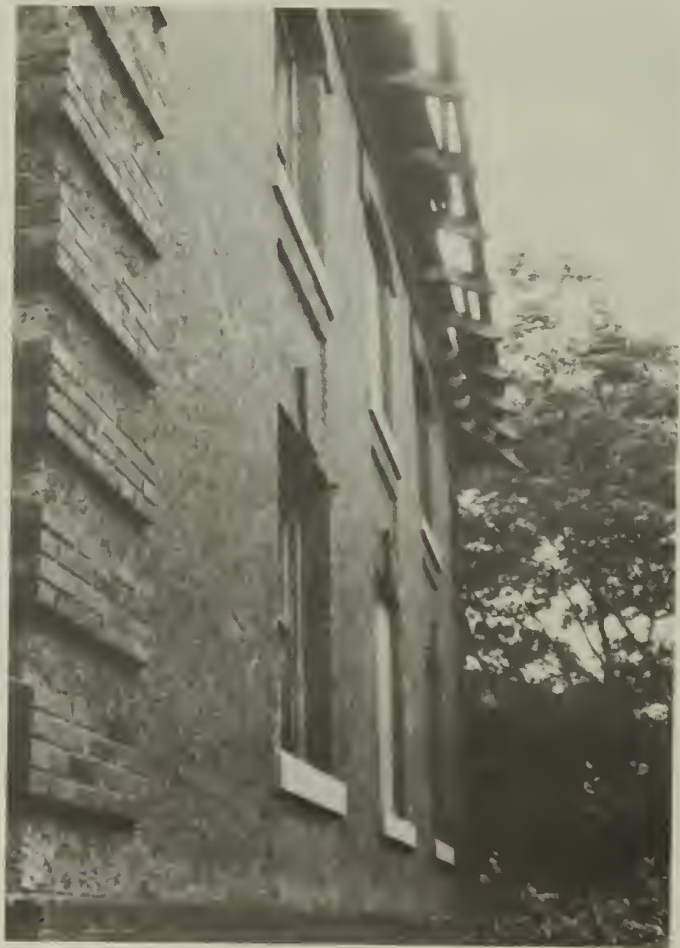
Wood surfaces exhibit general surface weathering which has resulted in the crazing, cracking and lifting of protective painted coatings to expose the wood subsurface. The wooden roof overhang of the west elevation of the office building exhibits a 70% loss of fascia boards with the wooden brackets remaining (photo 15).

15. Deteriorated wood eaves, west elevation.

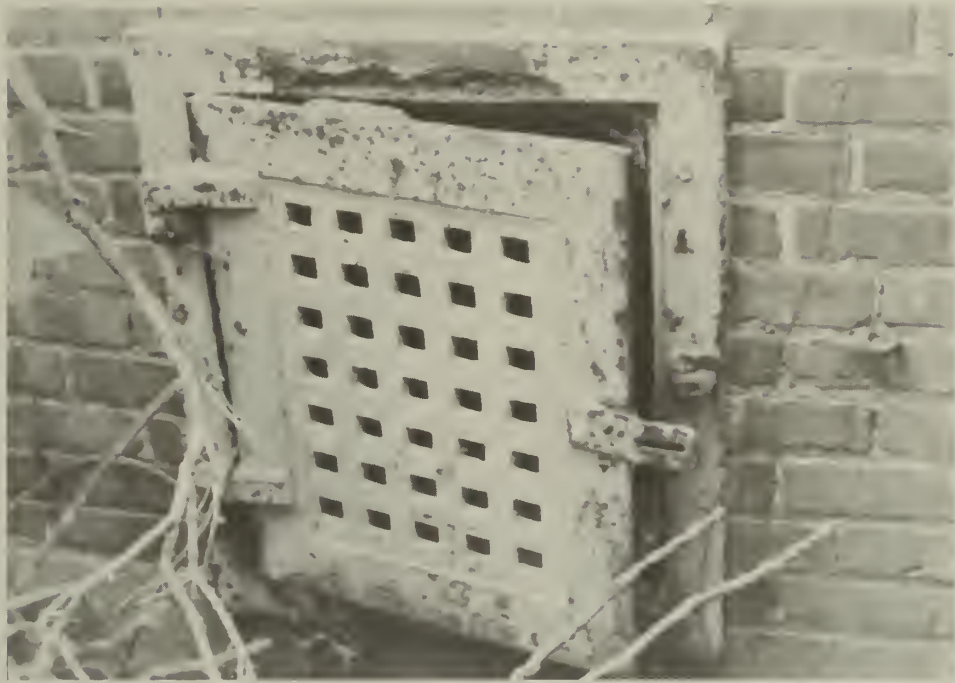
16. Corroded iron lintel, door leading to pipe cellar, mortuary, north elevation.

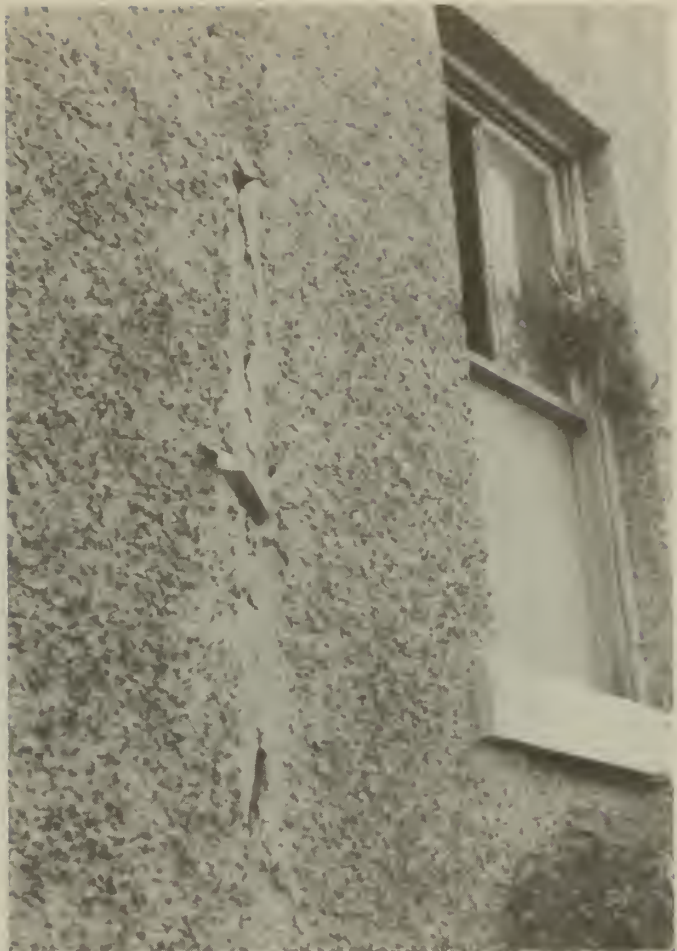
9. Loss and cracking of pebble dash aggregate in area of removed downspout, west elevation.

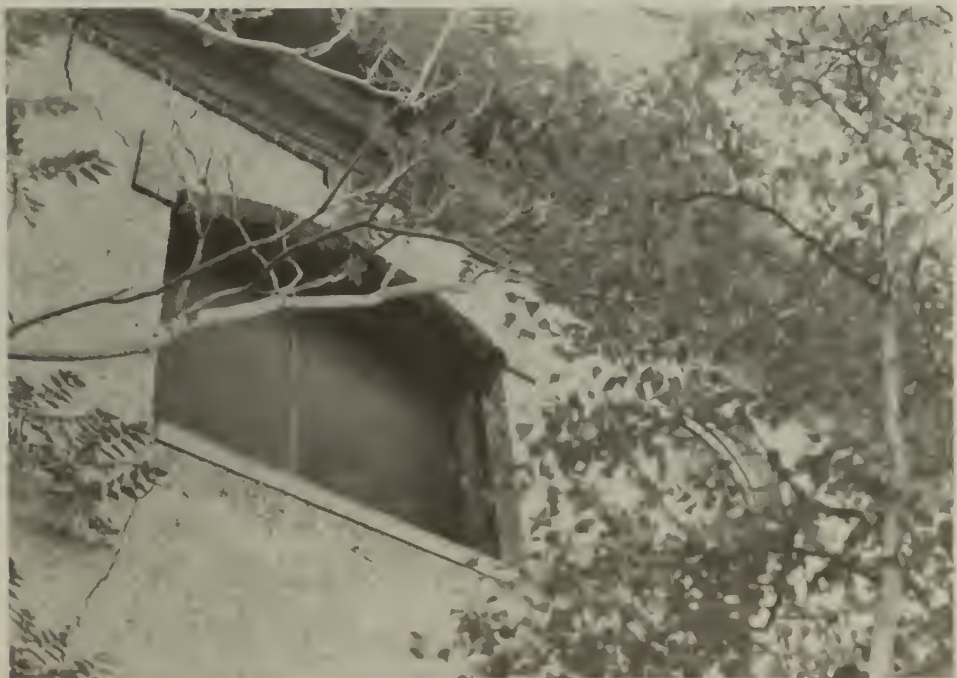
10. Crack near second story steel doors, west elevation.

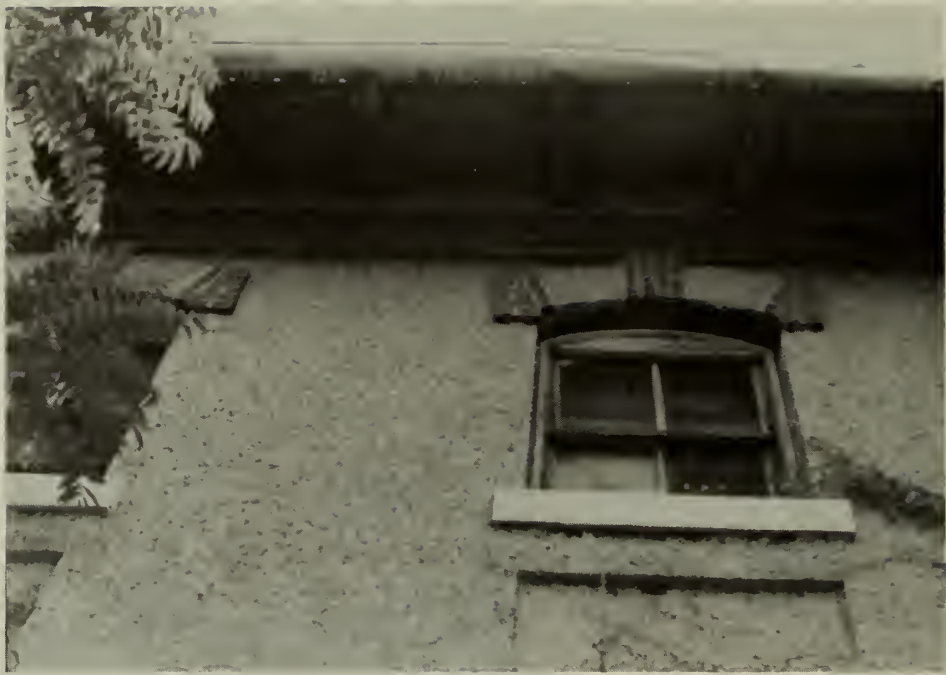
11. Carbon soot staining beneath lintel and sill; second story window, south elevation.

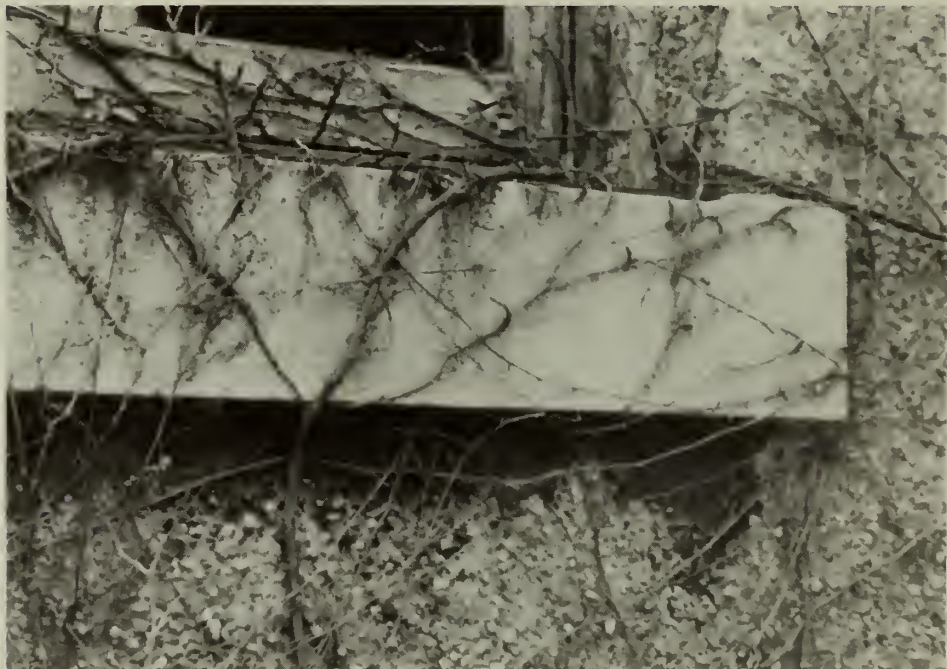
12. Tar-like sealant beneath window sill, east elevation.

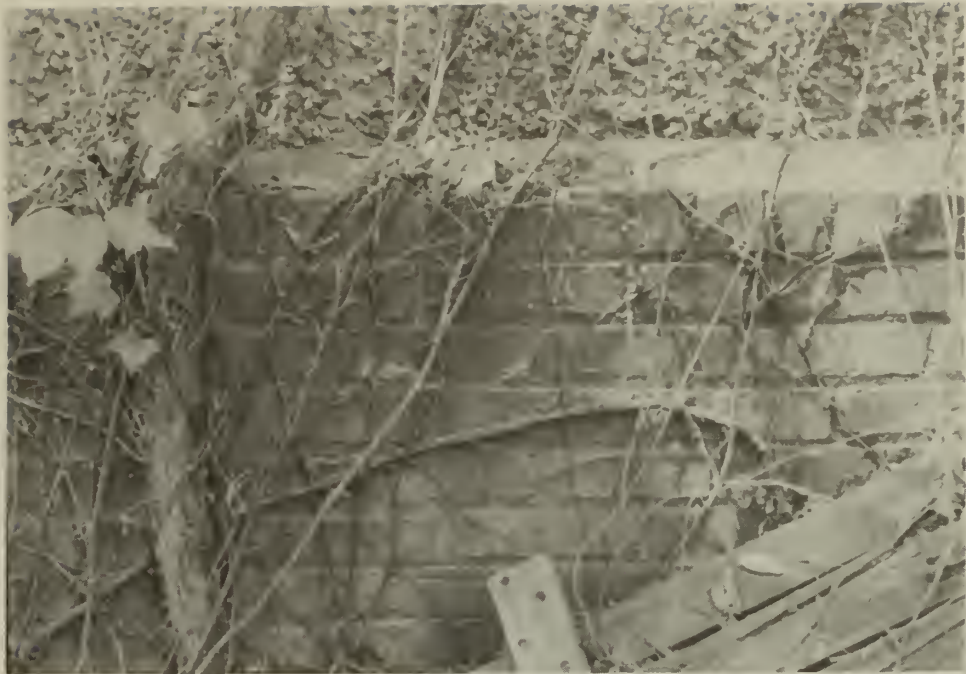
13. Green biological staining, brick base, east elevation.

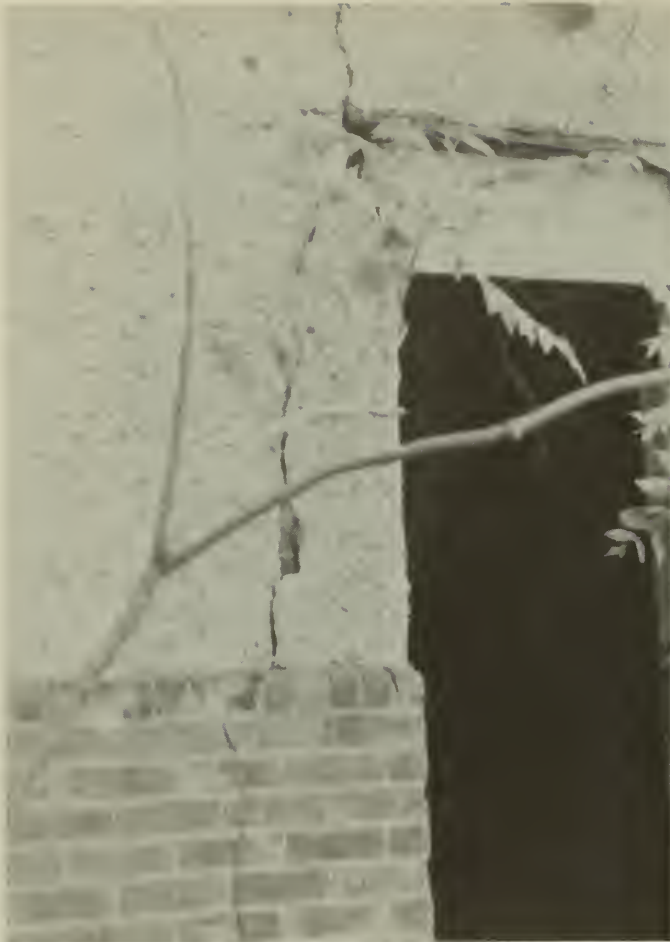
The vertical crack in the west wall seems to be the result of expansion and contraction of the long (103') east/west wing due to the building not being heated. This crack, which appears to be wide, should be routed out and a back-up rod and expansion joint sealant installed. The possibility of further cracking due to expansion and contraction should be eliminated once the building is heated.

15. Vertical crack, north of double steel doors, west elevation.

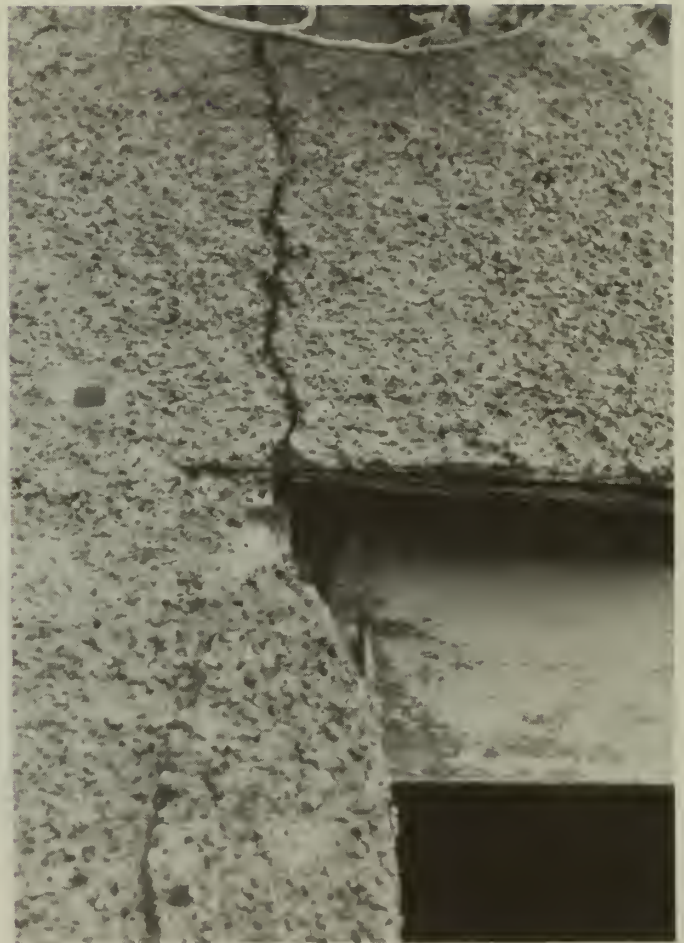
16. Upper portion of crack, west elevation.

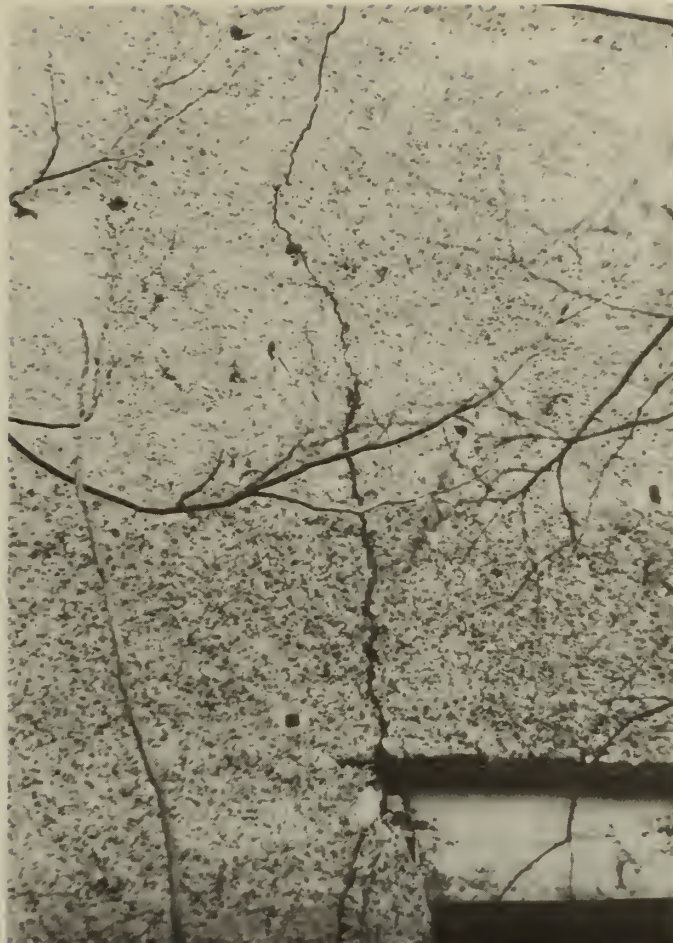
21. Vertical crack near steel doors, north end of west elevation.

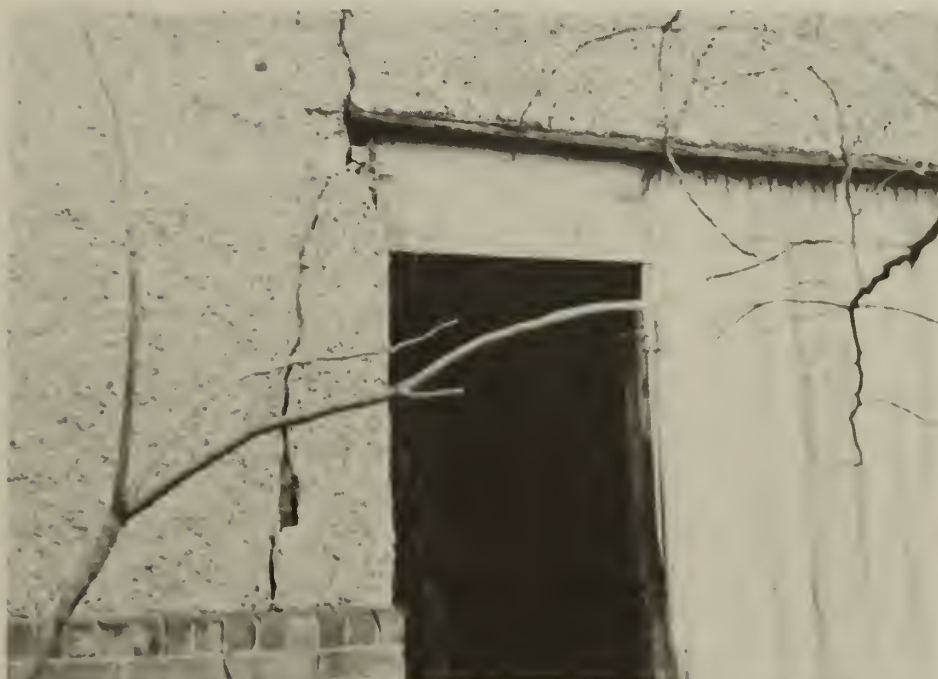
22. Vertical crack and corroded lintel above steel doors, west elevation.

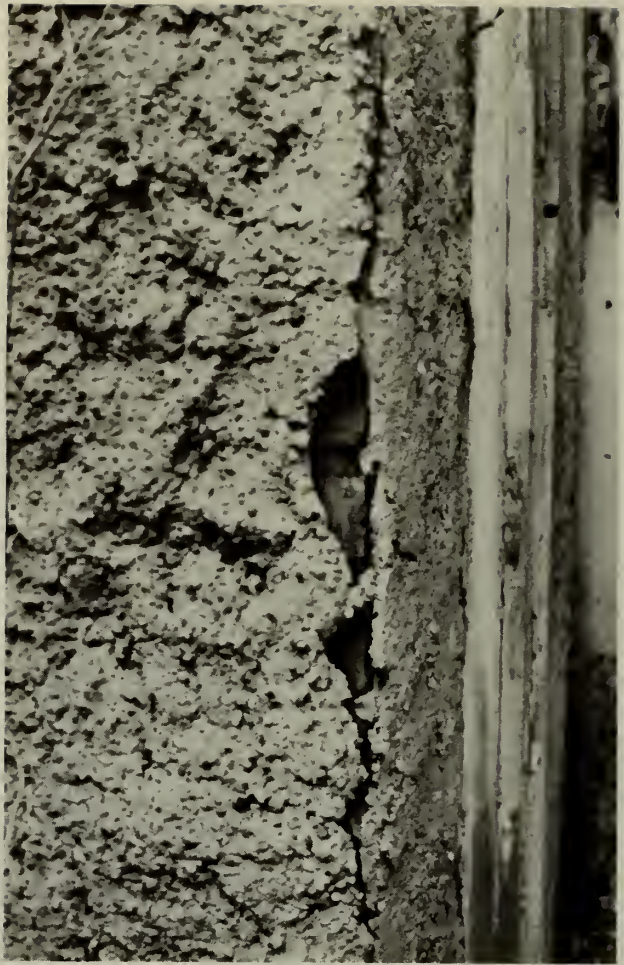
11. Cracked and spalled stucco;  
east elevation, ward C.

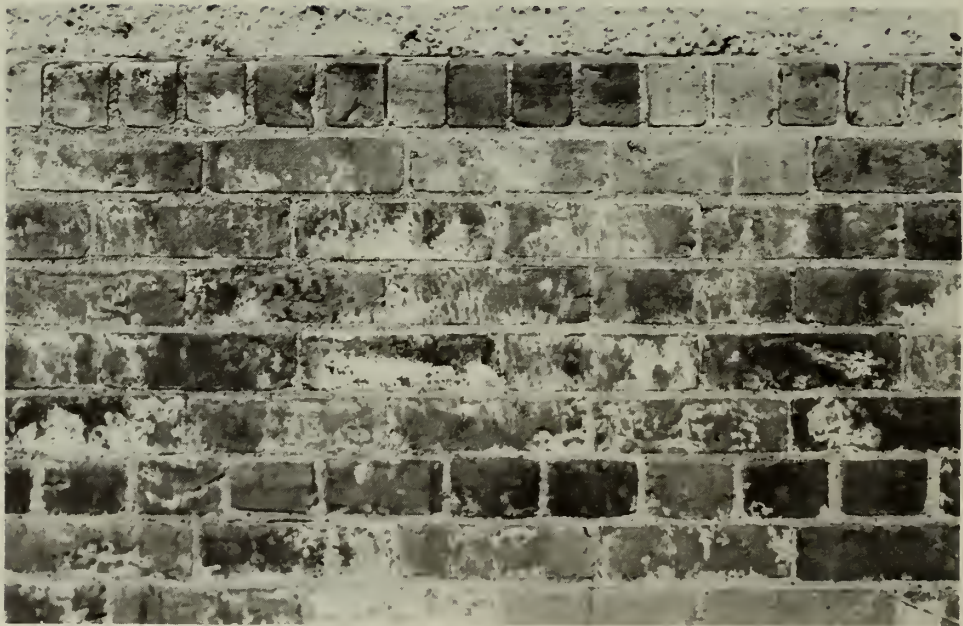
12. Ward A, west elevation; efflorescence,  
brick base.

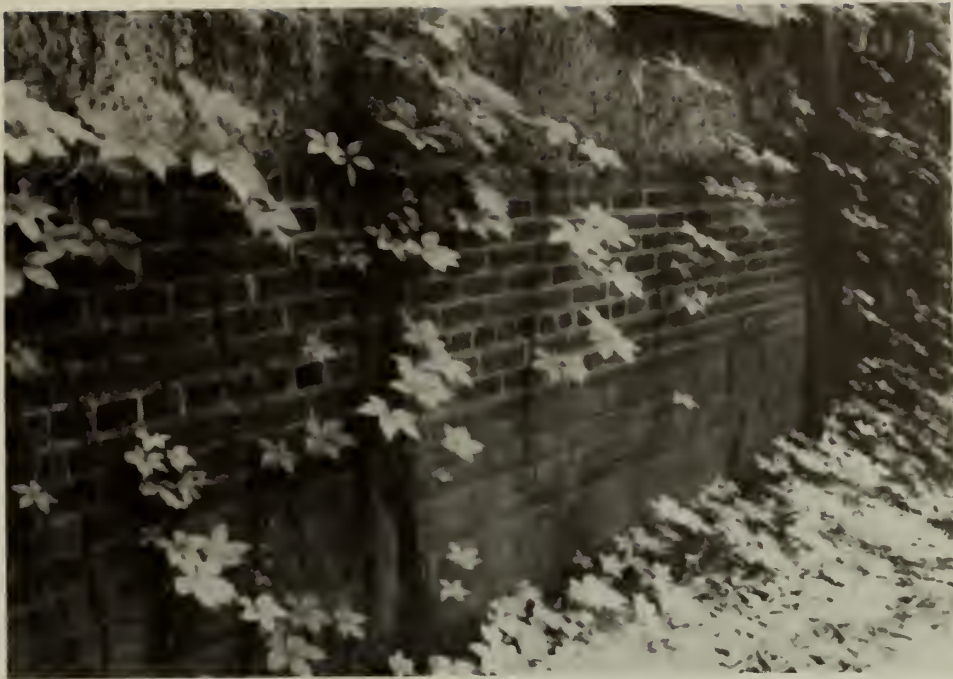
13. Ward D, west elevation; biological staining of brick base.

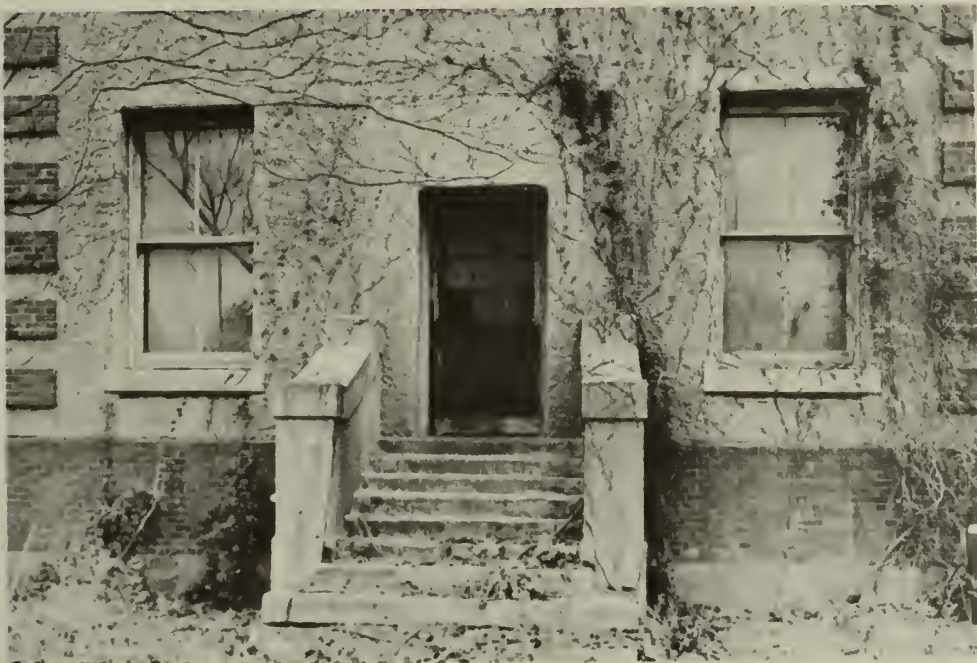
14. Ward B, south elevation; pitted and rusted metal door.

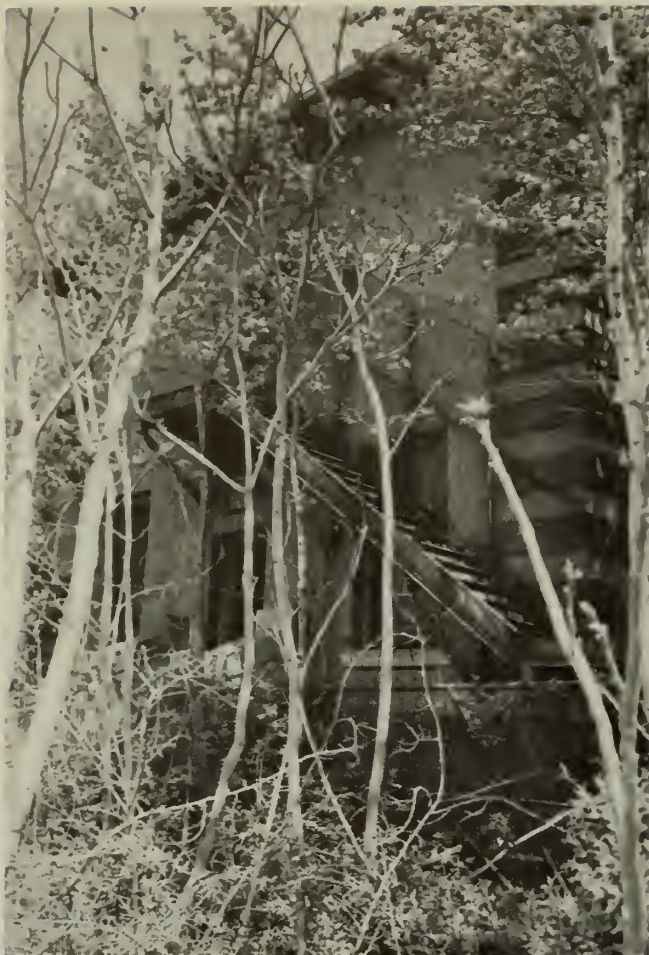
15. Ward C, north elevation;  
rusted fire escape.

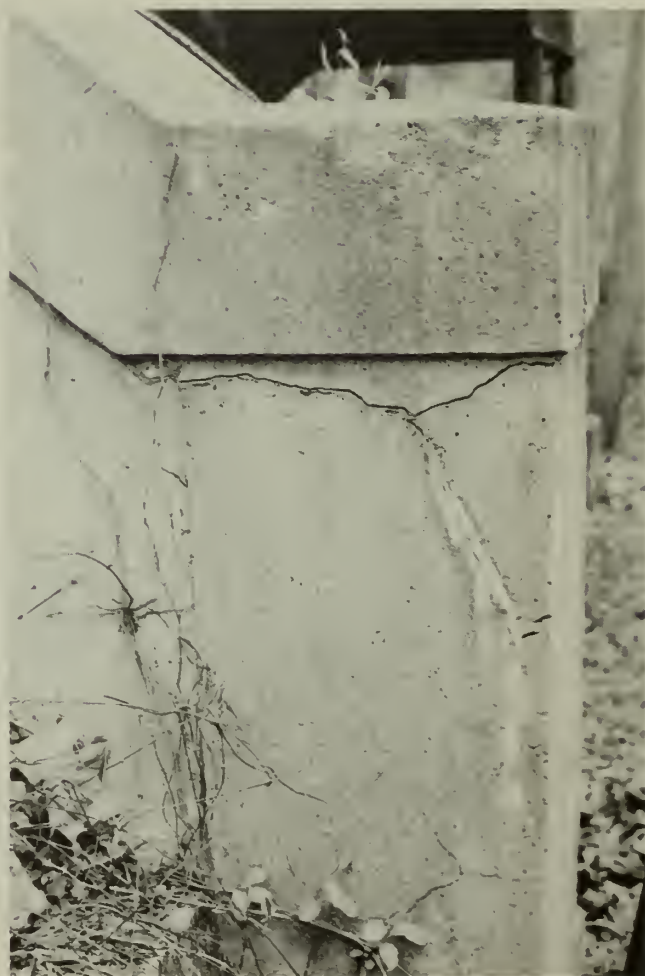
16. Cracked concrete balustrade,  
north elevation, ward D.

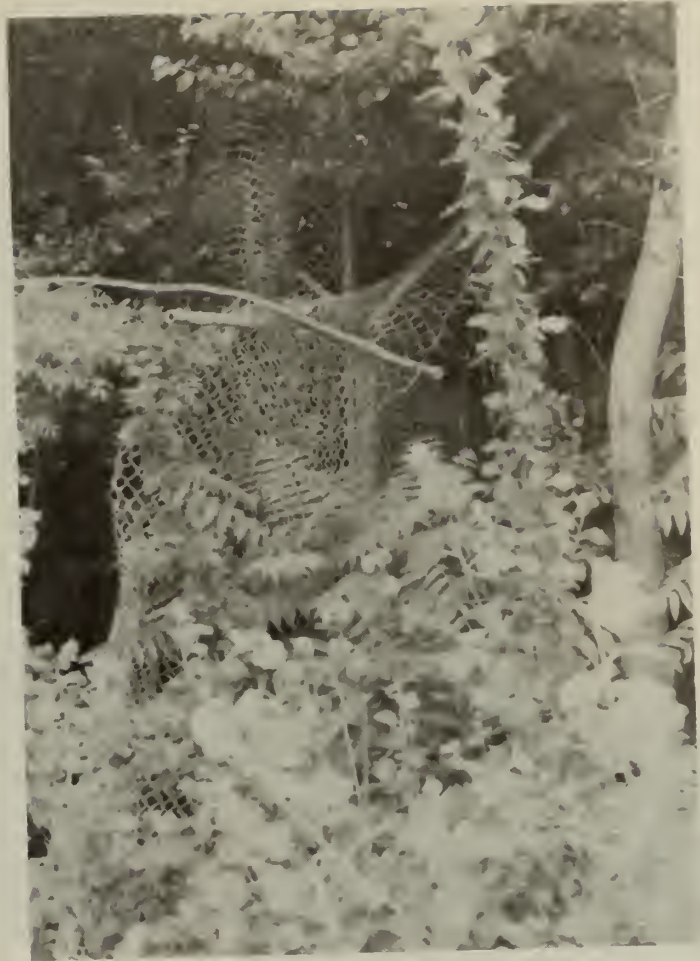
17. Deteriorated chain link fence between wards A and E.

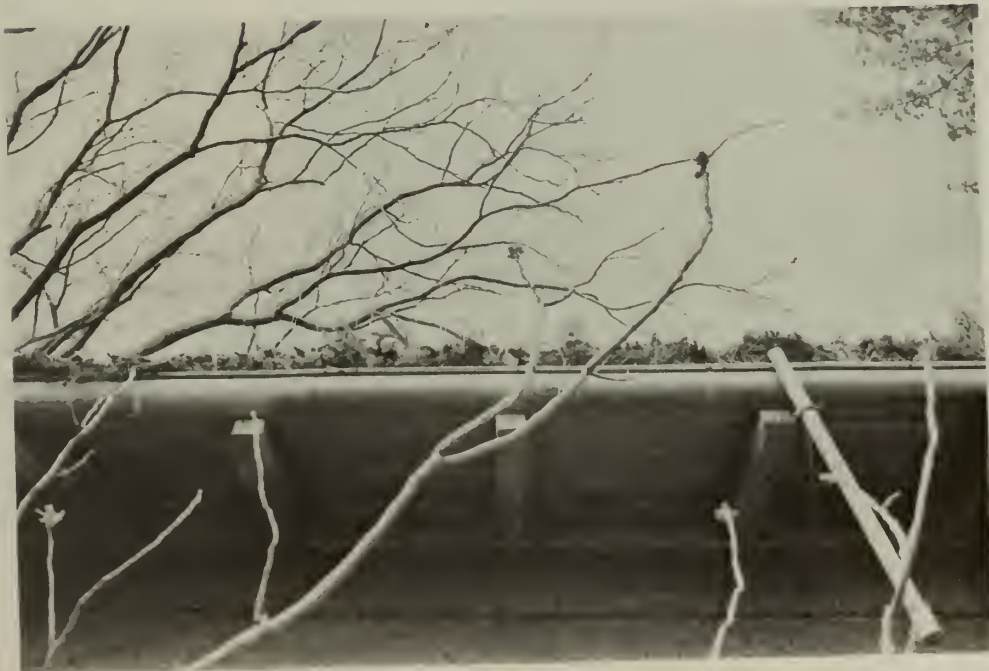
18. Gutter clogged by vegetation, south elevation, ward F.

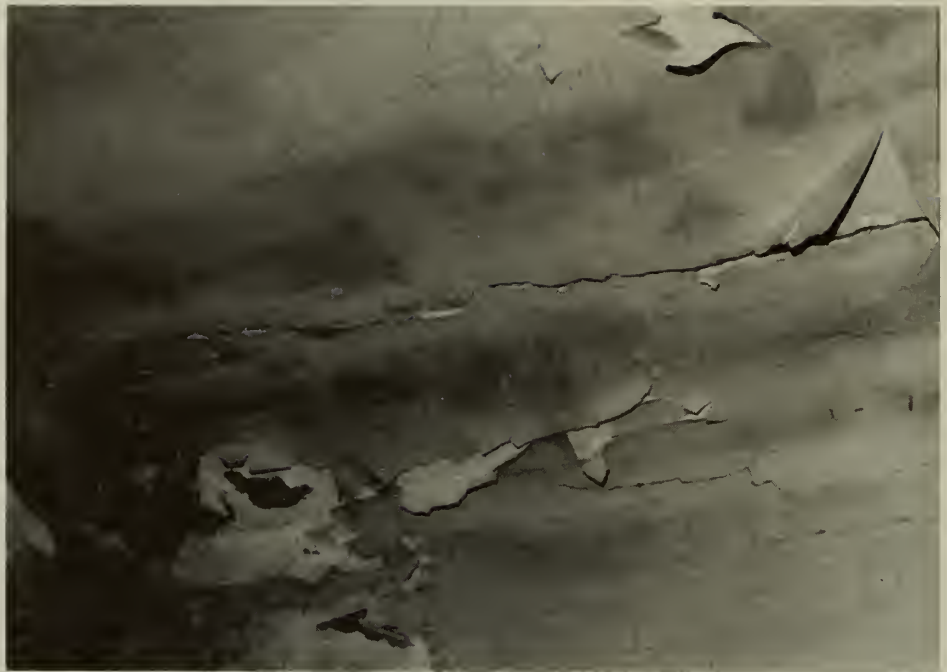
19. Ceiling cracks, room 205, evident in wards A, B, and G.

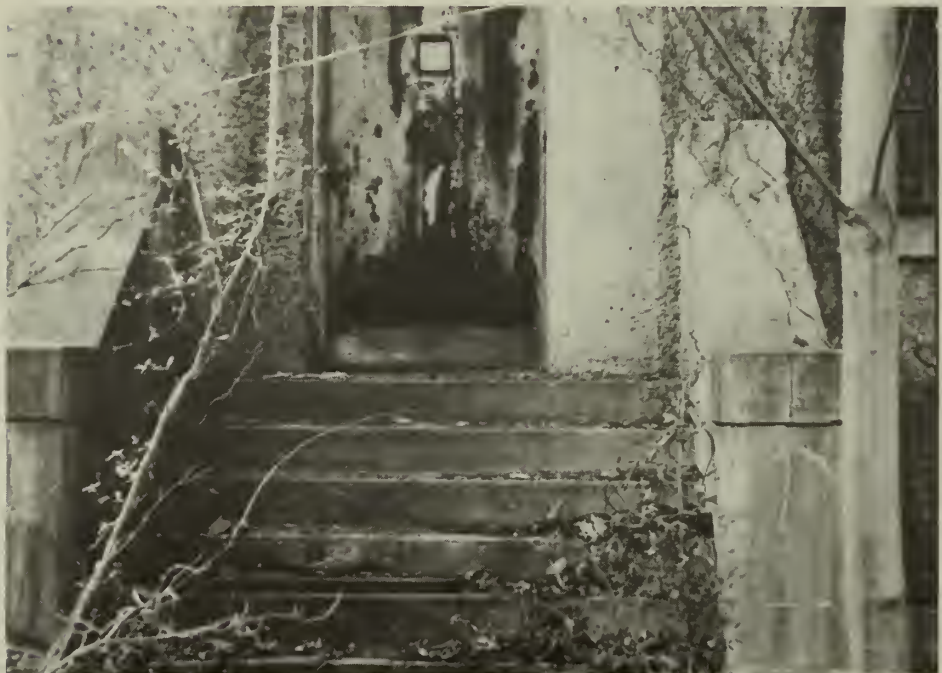
20. Ward G, north elevation stoop; crack in concrete balustrade.

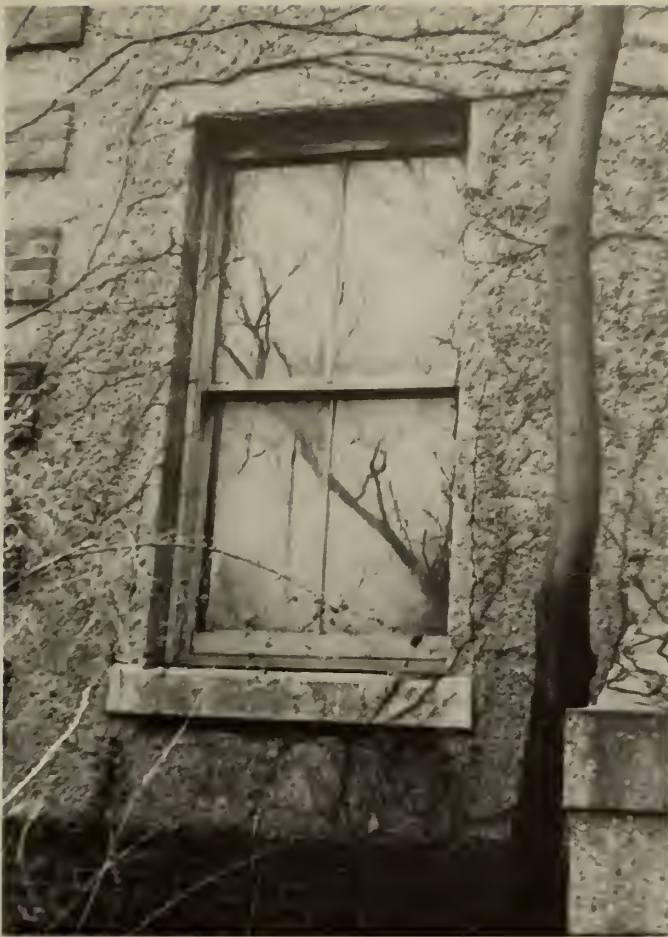
21. Cracks in stucco at window opening, north elevation, ward H.

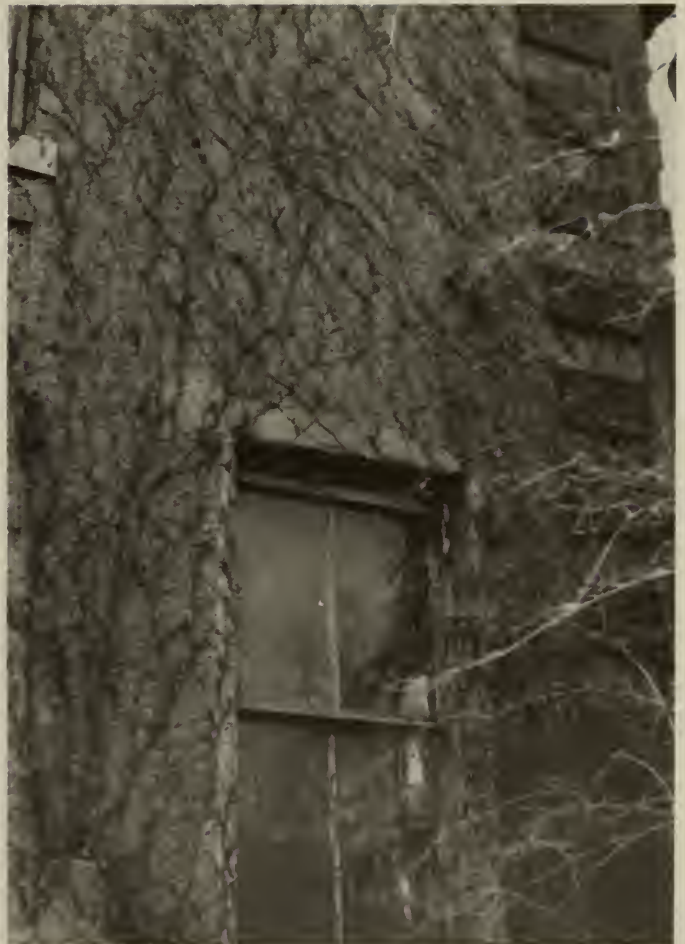
22. Cracks in stucco at window opening, north elevation, ward H.

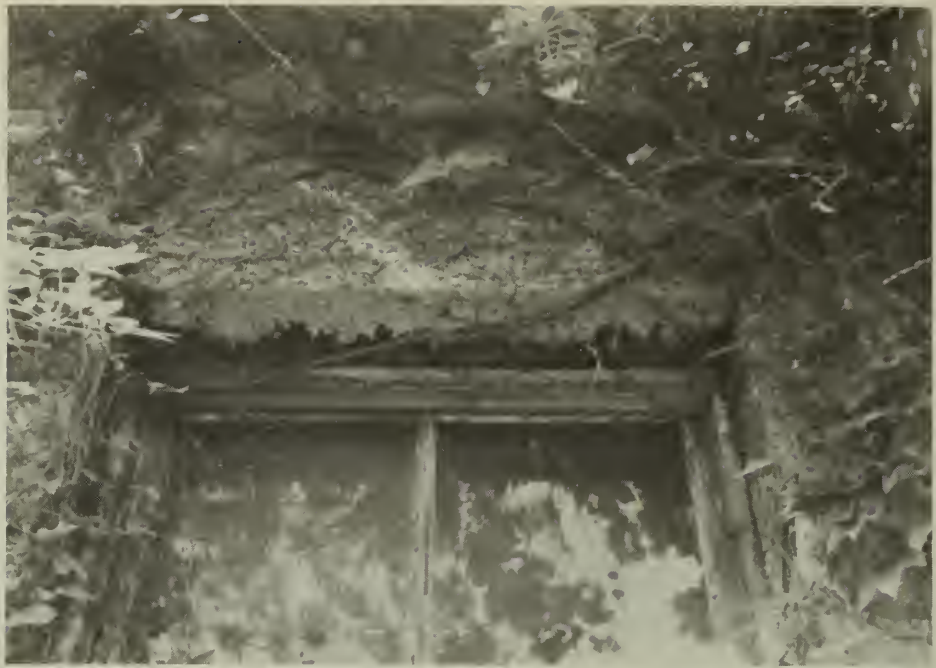
14. Administration building, carbon soot staining beneath window lintel, north elevation.

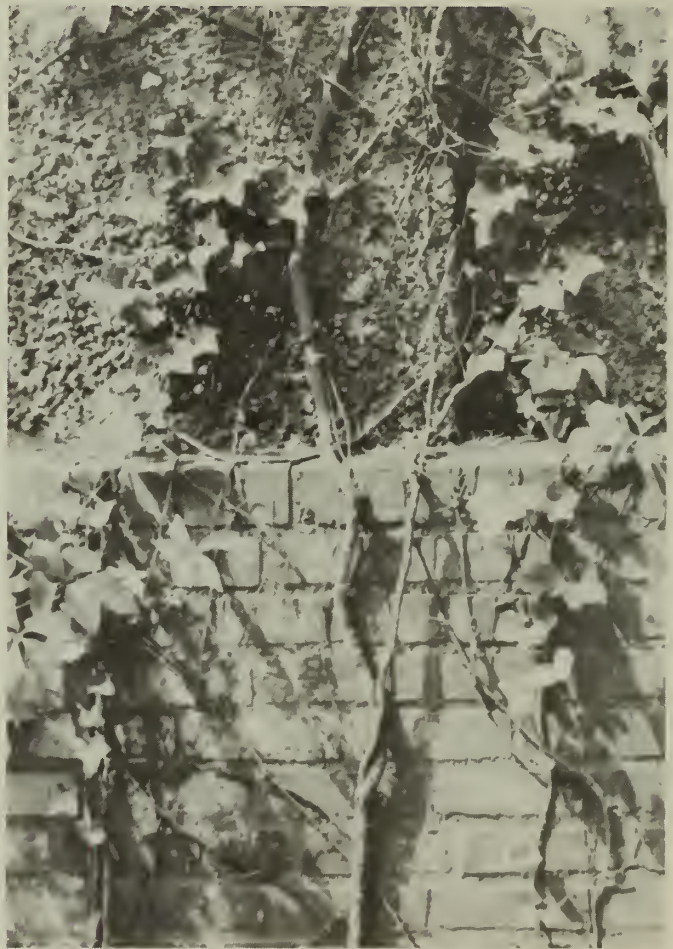
15. Efflorescence and green biological staining, base of north elevation, administration building.

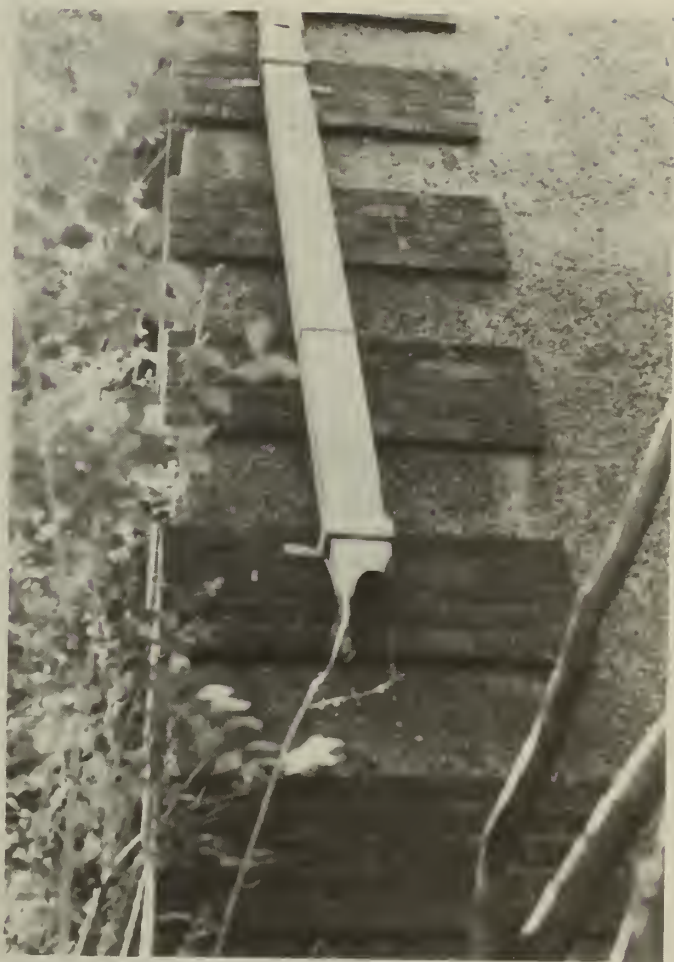
17. Damaged downspout, north end of west elevation, administration building.

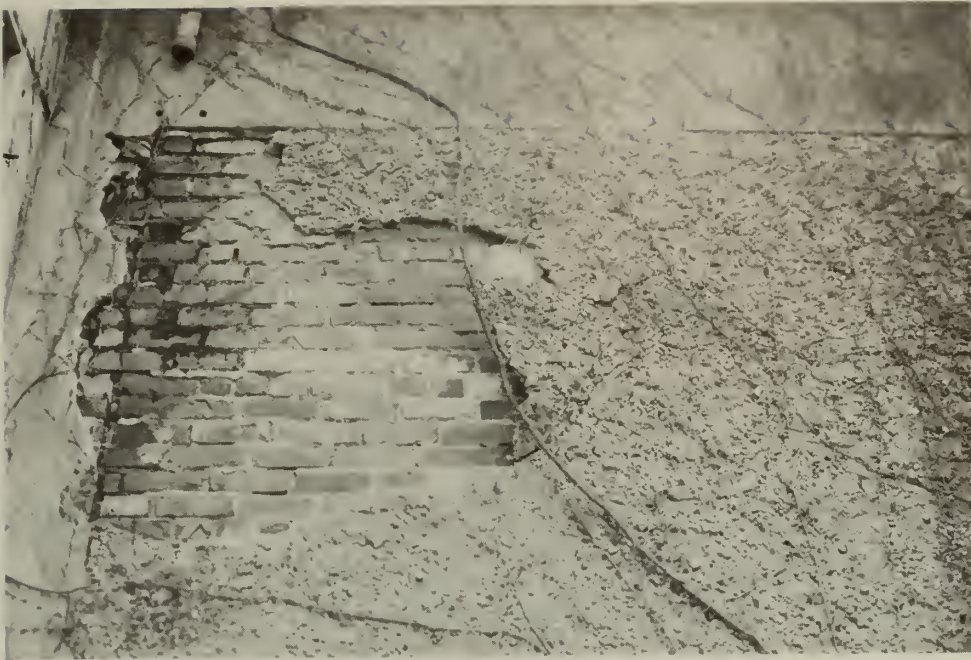
20. Spalling of pebble dash, west elevation of kitchen link to covered way 9C.
